**Flood Control Project Maintenance
Levee Inspections**

Fall 2015 Levee Maintenance Deficiency Summary Report

Reclamation District No. 2075 McMullin

Levee Inspection Report By Mile - Fall 2015

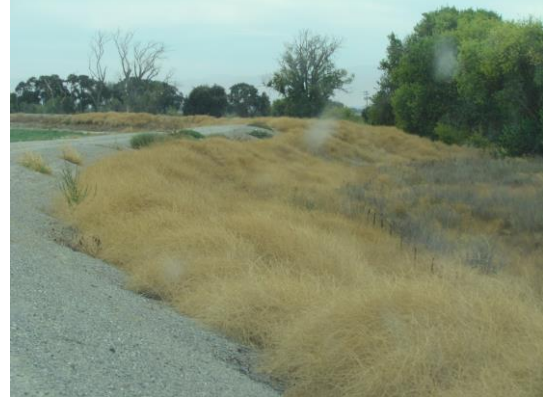
Photo 1 of 1 : FA_2015_RD2075_315_8_20151001_00009.jpg

LM Start	0.09	Rating **	U	Issue No.	8
LM End	0.14	Issue Type +	Ma	Location *	WS
Category	Earthen Levee			GPS Latitude/Longitude	
				Start	End
Item	Vegetation			37.748575 °	37.747847 °
				-121.289728 °	-121.289550 °
DWR ID	DWR_RD2075_01_f_2015_8				
Action/Comments					
Control annual grass and weeds on the levee slopes and easements. Inspector Comments: Remove the sprayed weeds from the waterside slope.

Waterside levee slope looking downstream slope covered with tumbleweeds.

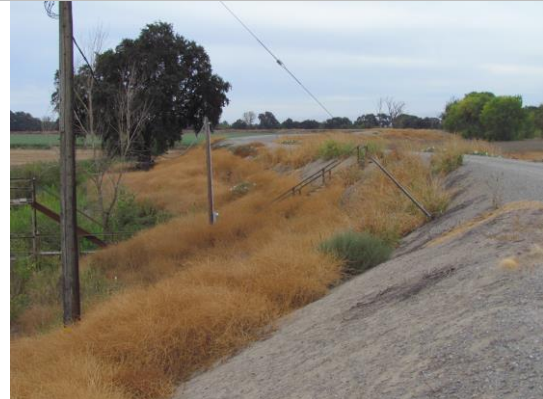
Photo 1 of 1 : FA_2015_RD2075_315_7_20151001_00010.jpg

LM Start	0.09	Rating **	U	Issue No.	7
LM End	0.47	Issue Type +	Ma	Location *	LS
Category	Earthen Levee			GPS Latitude/Longitude	
				Start	End
Item	Vegetation			37.748575 °	37.743222 °
				-121.289728 °	-121.289183 °
DWR ID	DWR_RD2075_01_f_2015_7				
Action/Comments					
Control annual grass and weeds on the levee slopes and easements. Inspector Comments: Remove the sprayed weeds from the levee section.

Looking downstream from landside levee slope, weeds were sprayed not dragged off slope.

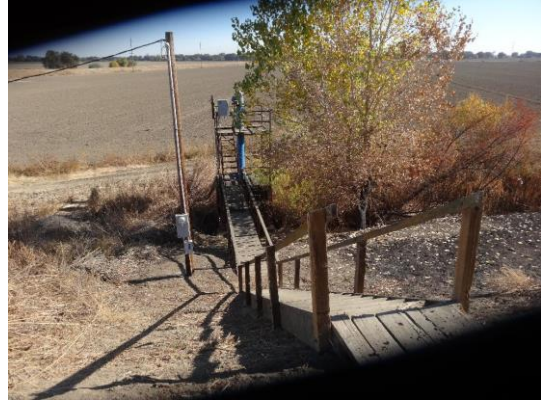
Photo 1 of 3 : UCIP_FA_2015_2717.jpg

Inspector Comments: FS_ID:24663
 DS_ID:24735
 EP_NO: 4736
 FS_HLM: 0.1207
 Repair Type: Non-Urgent
 Crossing Status: Found
 UCIP Comments: - pipe not visible on waterside.- no access to concrete riser on waterside.- blocked siphon breaker.
 FIELD_STRUCT_DESC: 14-inch steel pipe through the levee, 4.0 feet below the crown. Pump mounted on pile structure in drainage ditch on the landside. Siphon breaker in concrete riser unit on the waterward slope. Concrete distribution box at the toe of waterward slope. (App. No. 4736 - E. E. Brown). O&M Manual SJR 003, Dec. 1968.
 FS Date: 11/13/2013

LS view: walkway, pump, service pole, and intake structure.

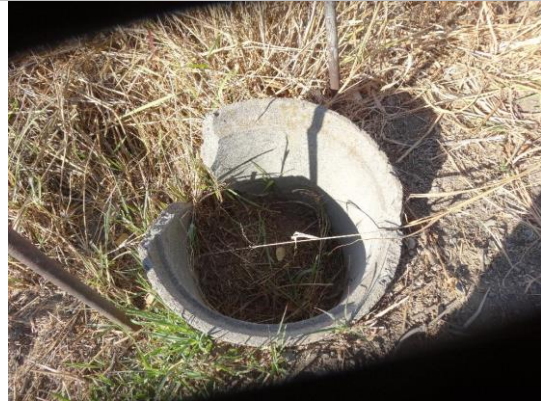
Photo 2 of 3 : UCIP_FA_2015_2718.jpg

WS view: concrete pipe riser with siphon breaker on levee slope.

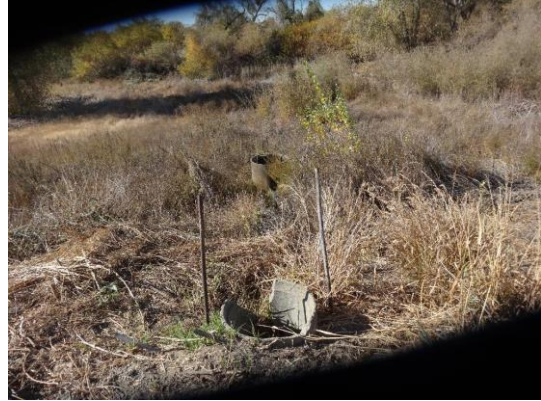
Photo 3 of 3 : UCIP_FA_2015_2719.jpg

WS view: concrete standpipe (top) and concrete pipe riser (bottom) on levee slope.

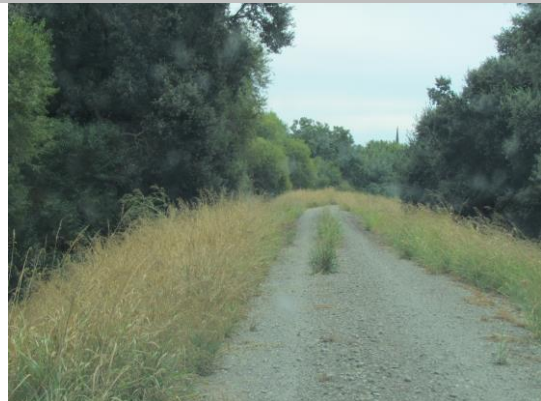
Photo 1 of 1 : FA_2015_RD2075_315_15_20151001_00011.jpg

LM Start	1.14	Rating **	U	Issue No.	15
LM End	1.36	Issue Type +	Ma	Location *	LS
Category	Earthen Levee			GPS Latitude/Longitude	
				Start	End
Item	Vegetation			37.737962 °	37.735370 °
				-121.281678 °	-121.282915 °
DWR ID	DWR_RD2075_01_f_2015_15				
Action/Comments					
Control annual grass and weeds on the levee slopes and easements.

Looking downstream at the landside levee slope johnson grass is present from shoulder to toe, same for the waterside slope.

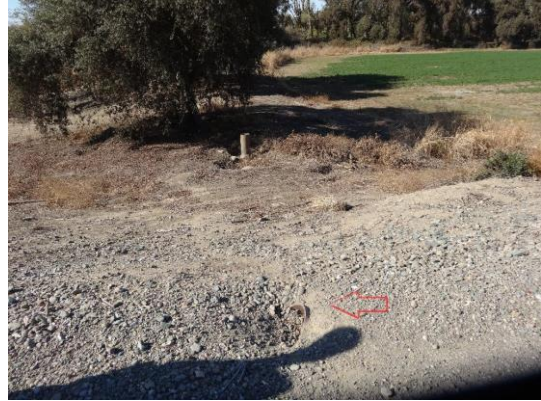
Photo 1 of 3 : UCIP_FA_2015_2571.jpg

Inspector Comments: FS_ID:24666
 DS_ID:24737
 EP_NO: N/A
 FS_HLM: 2.345
 Repair Type: Non-Urgent
 Crossing Status: Found
 UCIP Comments: - service pole on landside.- looks abandoned.
 Walkway in dilapidated condition.
 FIELD_STRUCT_DESC: 16-inch pipe through the levee, 4.5 feet below the crown. Pump mounted on pile structure in drain ditch on the landward side. Siphon breaker in CM riser unit on the waterward slope.
 O&M Manual SJR 003, Dec. 1968.
 FS Date: 11/13/2013

WS view: concrete standpipe (top) and steel pipe riser (bottom marked) on levee slope.

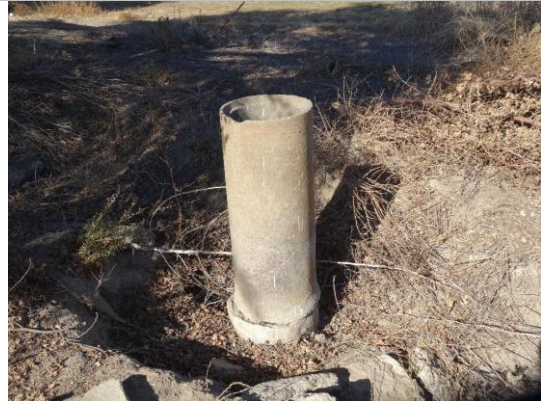
Photo 2 of 3 : UCIP_FA_2015_2782.jpg

WS view: concrete standpipe on levee toe.

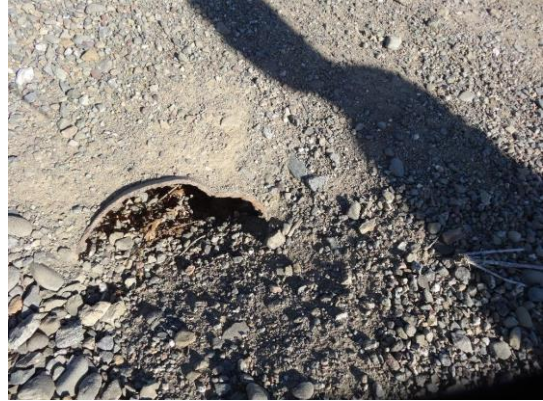
Photo 3 of 3 : UCIP_FA_2015_2783.jpg

WS view: blocked siphon breaker in steel pipe riser on levee slope.

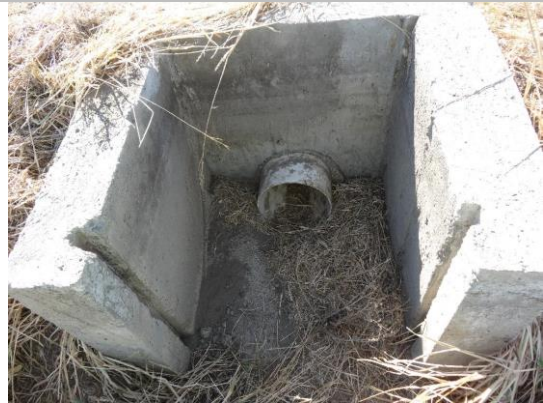
Photo 1 of 3 : UCIP_FA_2015_2605.jpg

LS view: concrete U type headwall on levee toe and open PVC pipe.

Inspector Comments: FS_ID:41721
 DS_ID:24746
 EP_NO: N/A
 FS_HLM: 3.906
 Repair Type: Non-Urgent
 Crossing Status: Found
 UCIP Comments: Several concrete structure with Alfalfa valve. Only steel pipe visible on river bank. Service pole on waterside. New field discovered crossing.
 FIELD_STRUCT_DESC: 10-inch irrigation pvc pipe through the levee. Slant pump in river bank. Distribution box on levee berm on waterside. U type concrete headwall and open outlet on levee toe on landside.
 FS Date: 11/13/2013

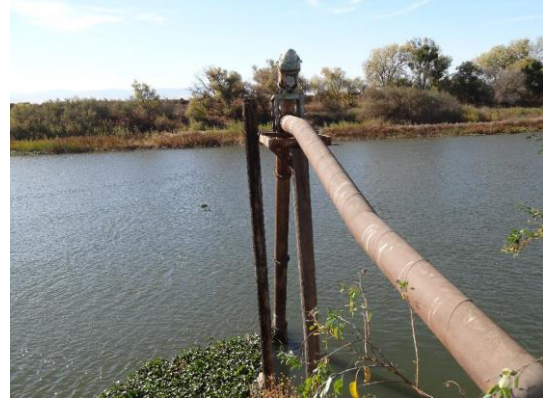
Photo 2 of 3 : UCIP_FA_2015_2606.jpg

WS view: slant pump on timber pile in the stream.

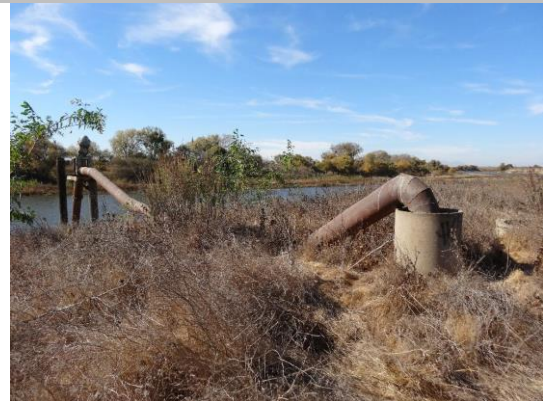
Photo 3 of 3 : UCIP_FA_2015_2607.jpg

WS view: slant pump and concrete distribution box on levee berm.

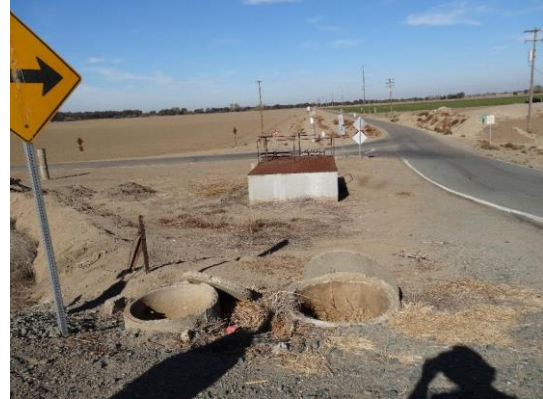
Photo 1 of 2 : UCIP_FA_2015_1192.jpg

LS view: siphon breakers in concrete pipe risers (bottom) on levee slope. Concrete distribution box on levee toe (top).

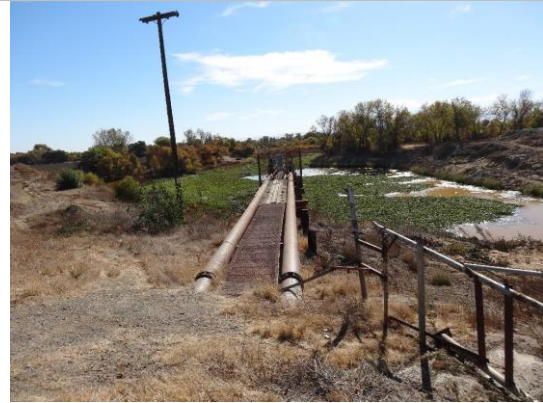
Photo 2 of 2 : UCIP_FA_2015_1193.jpg

WS view: two pipes, walkway to pump and pile structure in the stream.

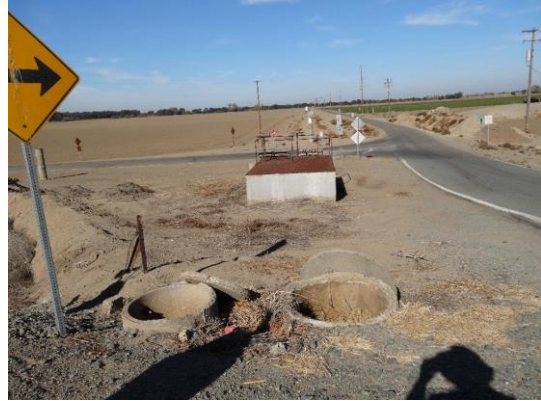
Photo 1 of 3 : UCIP_FA_2015_1194.jpg

LS view: siphon breakers in concrete pipe risers (bottom) on levee slope. Concrete distribution box on levee toe (top).

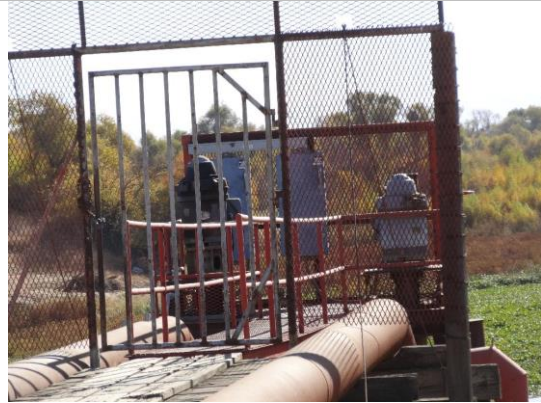
Photo 2 of 3 : UCIP_FA_2015_1195.jpg

WS view: closer view of two pumps and platform in the stream.

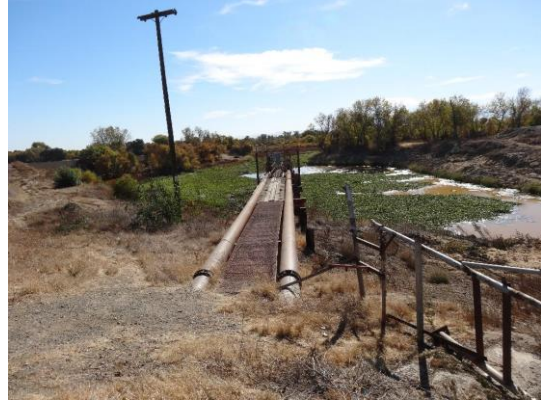
Photo 3 of 3 : UCIP_FA_2015_1196.jpg

WS view: two pipes, walkway to pump and pile structure in the stream.

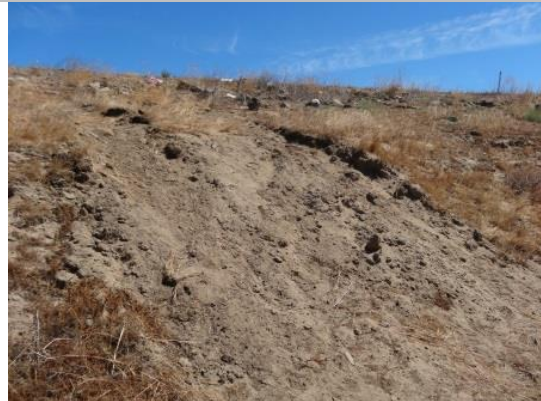
Photo 1 of 3 : SJR2015_RD2075U01RM64.34_13.jpg

Direct view of the levee slope. Note the loose soil possibly caused by runoff.

Inspector Comments: 08/28/2015: No significant change observed. Loose material is visible at the upper levee slope. The loose soil may have been caused by runoff.
 08/18/2014: No significant change observed.
 09/10/2013: No significant change observed.
 09/13/2012: No significant change observed.
 08/18/2011: No significant change observed. Some new material added to the water side levee slope, but the added material is loose and seems not helping the levee protection.
 10/05/2010: No significant change observed. Levee slope has minimal vegetation and lacks rip rap protection. Sandy material found on the lower and middle slope is an undesirable material to have on a levee.
 08/05/2010: Recommended for annual assessment and monitoring during flood events, per CLRO.
 08/20/2009: No major change since last visit; site is located in an oxbow; slope surface consists of very sandy material; there is a tree on site leaning and with exposed tree roots; site is recommended as a local maintenance issue, per CLRO CES Evaluation 2008 Report; Eddy Cordoza from the district is aware of the site and is looking for recommendation; site is previously rated "U".

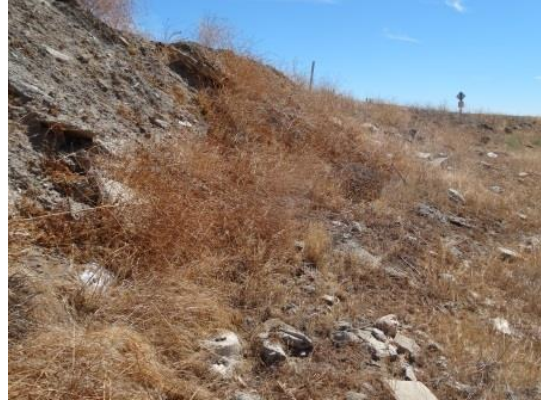
Photo 2 of 3 : SJR2015_RD2075U01RM64.34_15.jpg

Looking downstream at the erosion site.

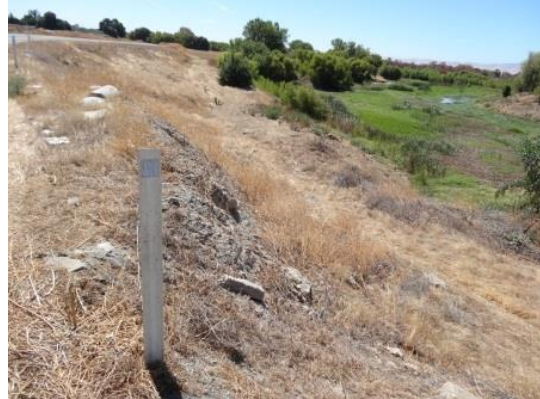
Photo 3 of 3 : SJR2015_RD2075U01RM64.34_2.jpg

Looking upstream at the site.

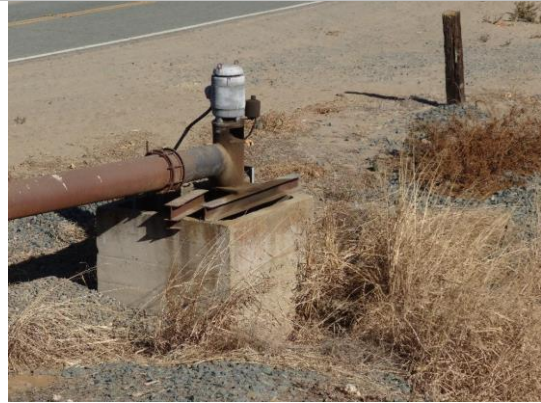
Photo 1 of 3 : UCIP_FA_2015_2879.jpg

LS view: closer view of pipe, pump and concrete sump in the drain ditch.

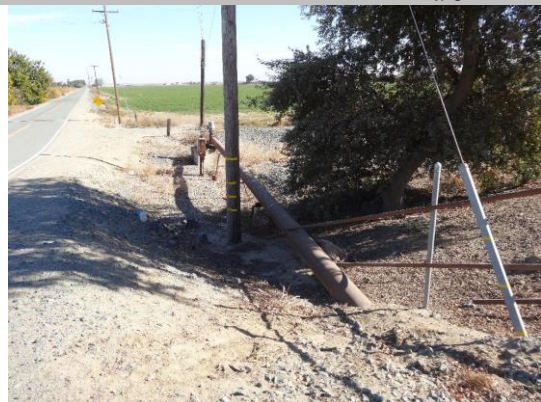
Photo 2 of 3 : UCIP_FA_2015_2880.jpg

LS view: pipe, pump and concrete sump in the drain ditch.

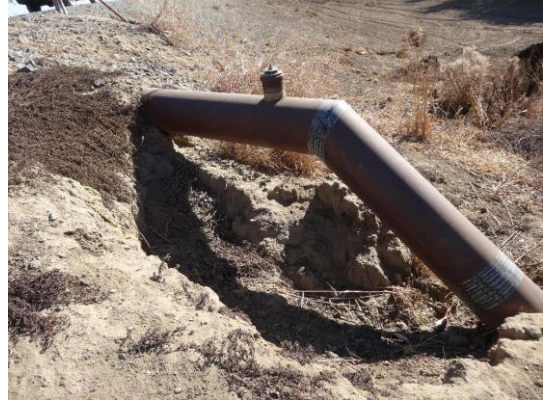
Photo 3 of 3 : UCIP_FA_2015_2881.jpg

WS view: siphon breaker on steel pipe on levee slope. Huge soil erosion due to siphon breaker leakage.

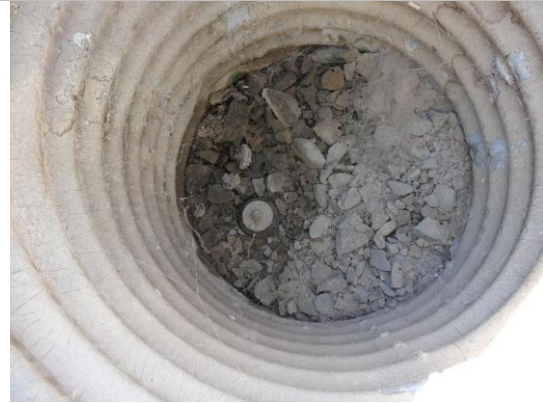
Photo 1 of 3 : UCIP_FA_2015_1197.jpg

UCIP Comments: - exposed deformed pipe on landside slope. Soil erosion also occurred around the deformed pipe. Walkway at pump on LS toe in poor structural condition.- a temporary 12-inch PVC pipe also found on both sides of the levee.

WS view: siphon breaker in CMP riser on levee shoulder.

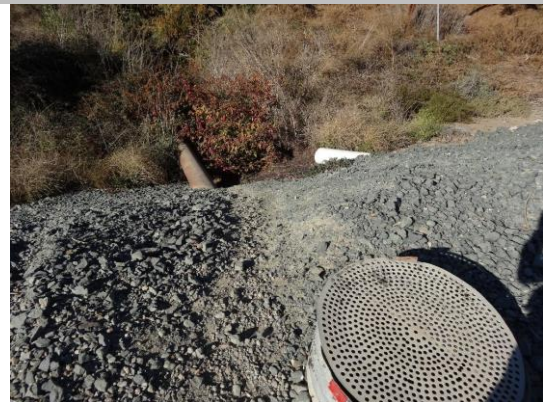
Photo 2 of 3 : UCIP_FA_2015_1198.jpg

WS view: CMP riser (bottom) on levee shoulder. Steel pipe (top) and temporary pvc pipe on levee slope.

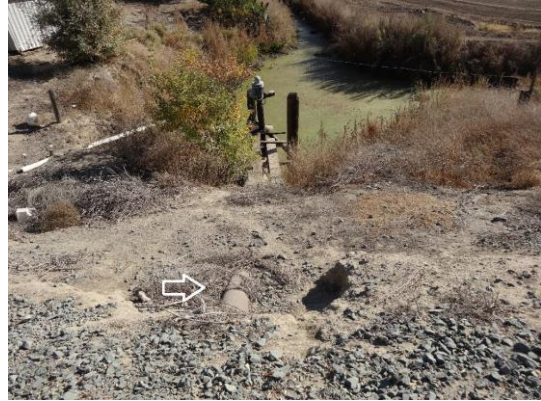
Photo 3 of 3 : UCIP_FA_2015_1199.jpg

LS view: deformed pipe and soil erosion around it (marked bottom). Pipe and pump on pile structure in drain ditch.

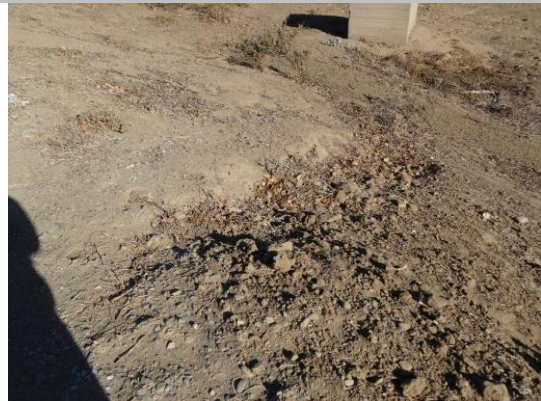
Photo 1 of 3 : UCIP_FA_2015_2723.jpg

LS view: levee subsidence along pipe alignment on levee slope.

Inspector Comments: FS_ID:24738
 DS_ID:24734
 EP_NO: 2150
 FS_HLM: 7.5128
 Repair Type: Non-Urgent
 Crossing Status: Found
 UCIP Comments: Most of the pipe exposed on waterside. Needs investigation regarding levee subsidence along pipe alignment on landside slope.
 FIELD_STRUCT_DESC: 12-inch pipe through the levee, 4.5 feet below the crown. Pump mounted on pile structure in the river. Concrete distribution box at the landward toe. Electric conduit through the levee.
 (App. No. 2150 - Cardoza) O&M Manual SJR 003, Dec. 1968.
 FS Date: 11/13/2013

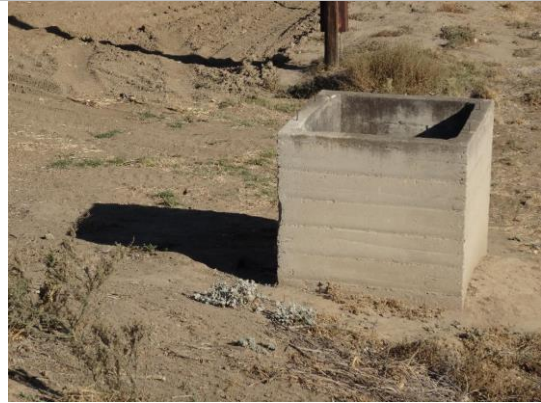
Photo 2 of 3 : UCIP_FA_2015_2724.jpg

LS view: concrete distribution box on levee toe.

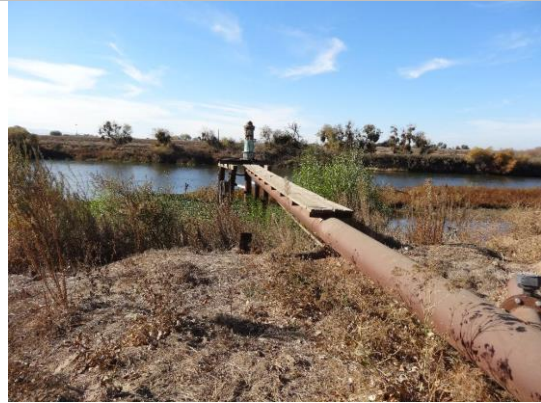
Photo 3 of 3 : UCIP_FA_2015_2725.jpg

WS view: pipe, walkway, and pump on pile structure in the river.
